1 **Assessing Safety Level of Bus Stops in the Absence of Crash Data**

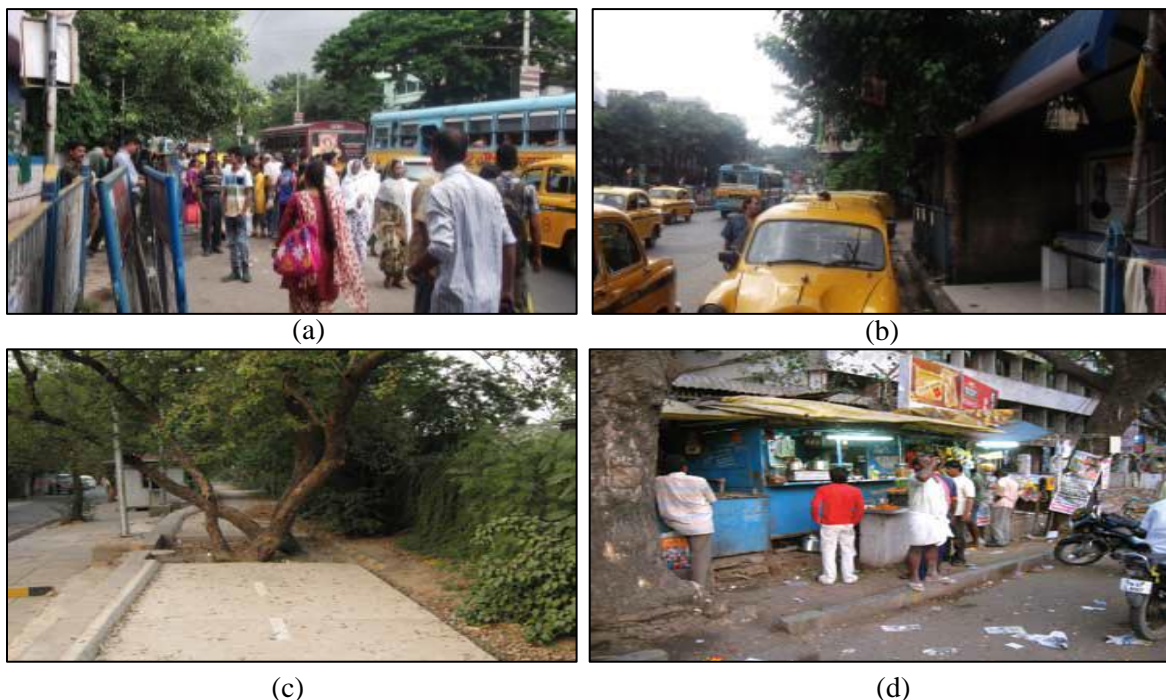
91 **FIGURE 1 (a) Absence of passenger waiting area; (b) On-street parking in front of waiting area;**
92 **(c) Physical obstruction on sidewalk; (d) Shops obstructing side walk facility.**

39 sidewalk, on street parking etc. (Figure 1) are the major issues of concern. It is observed that these
40 deficiencies in and around bus stops lead to violations, such as encroachment of bus user into the roadway
41 while accessing and waiting for the bus, crossing the road at undesirable locations, loading/unloading of
42 passengers at multiple points on the roadway, etc. Further, it leads to the vehicle-pedestrian conflicts and
43 ultimately to accidents of different severity levels. Hence, there is a dire need to improve the safety
44 standards at the bus stops. However, in the case of emerging countries, such as India, owing to the serious
45 constraints in financial resources, institutional constraints etc. massive safety improvement works may not
46 be possible to execute within a short time span (9). Therefore, it is essential to develop a methodology to
47 prioritize the bus stop, which requires immediate attention, on the basis of safety level which will ensure

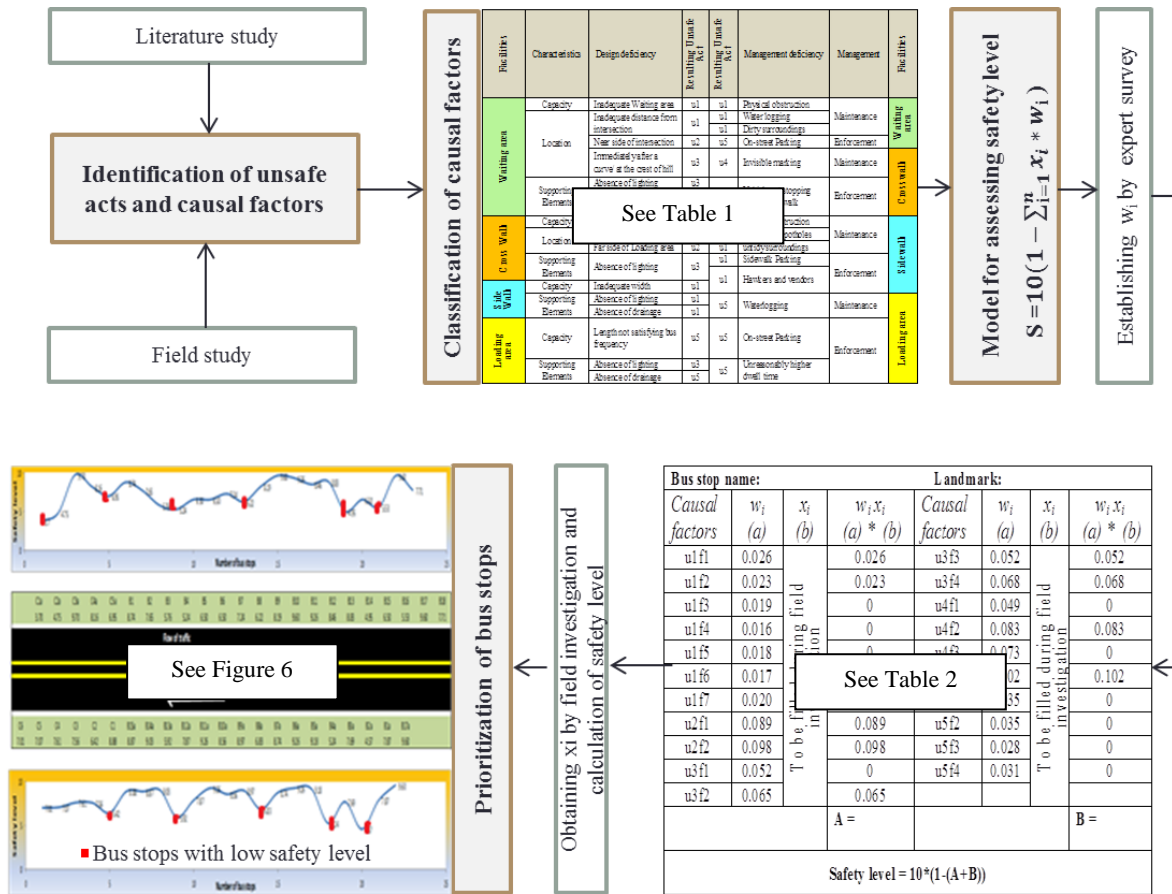
121
 122 **FIGURE 2 Flow chart showing methodology to assess safety level of bus stops.**
 123

94 A four step methodology to assess the safety level of the bus stops is discussed in this section and
95 is illustrated in Figure 2. It includes identification of unsafe acts in and around the bus stops and its causal
96 factors, classification of the causal factors under design and management deficiencies of bus stop
97 facilities, development of a model to assess the safety level of the bus stops, and the prioritization of bus
98 stops based on safety level.

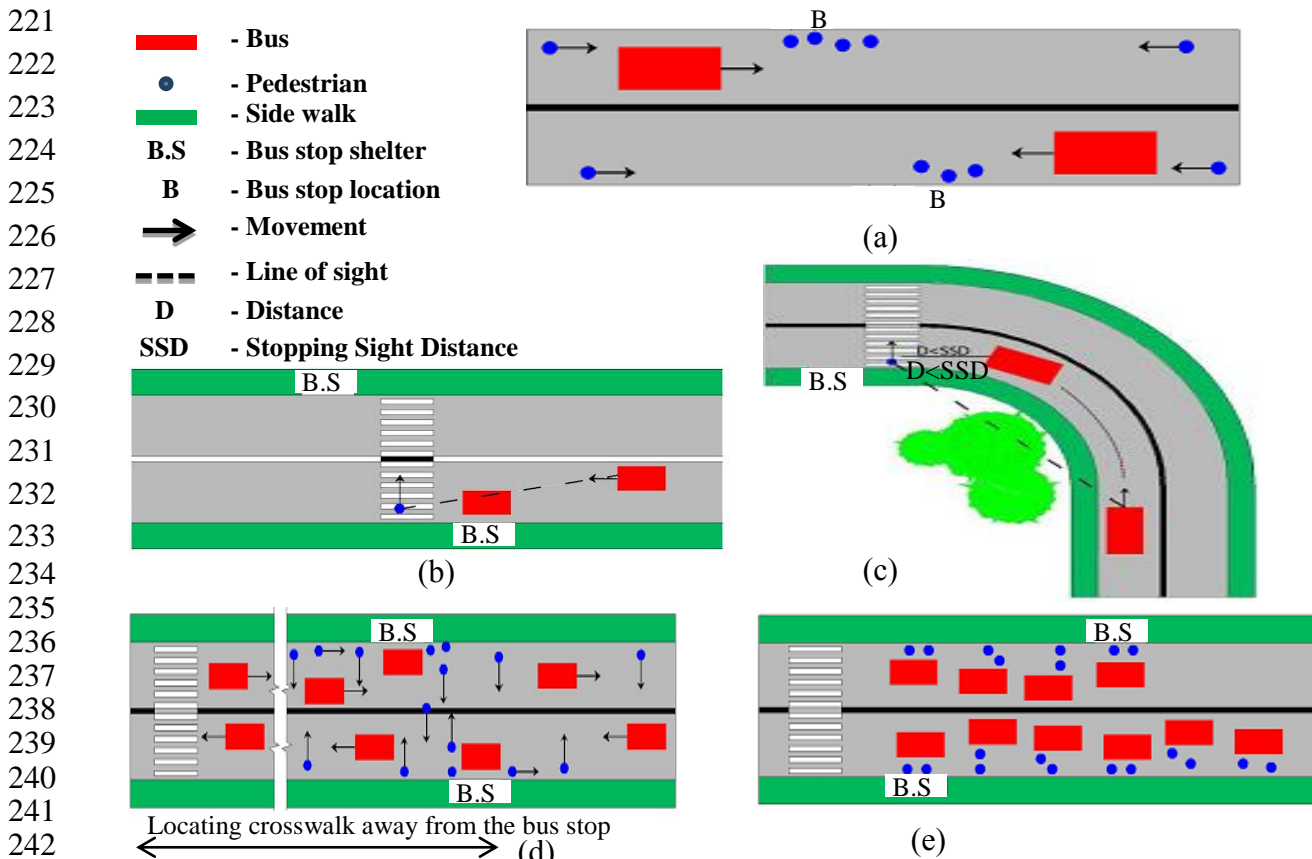
243 **FIGURE 4** (a) Encroachment of bus users to the roadway (u1); b) Crossing road in front of a
 244 stopped bus (u2); c) Crossing road at locations where sight distance with bus is inadequate (u3); d)
 245 Crossing road at undesigned locations (u4); e) Loading/unloading of passengers at multiple
 246 locations other than the designated bus stop locations (u5)

187 Bus users may encroach the roadway when they walk by using carriageway instead of using sidewalk or
188 wait for the bus on the carriageway rather than at the waiting area (Figure 4a). The factors which
189 predominantly contribute to this unsafe act include: Absence of/ inadequate waiting area (u1f1), absence
190 of/inadequate sidewalk facility (u1f2), lack of lighting facility along the sidewalk (u1f3), lack of drainage
191 facility (u1f4), untidy surrounding (u1f5), encroachment of sidewalk by parked vehicles (u1f6) and
192 presence of street vendors along the sidewalk (u1f7).

195 Field observations revealed that, in several cases, pedestrians attempt to cross road in front of a stopped
196 bus immediately after alighting from the bus (Figure 4b). As a result, pedestrians were unable to see the
197 vehicle approaching in the same direction as that of the stopped bus. Locating crosswalk at far-side of the
198 loading area (u2f1) and locating bus stop at nearside of the intersection (u2f2) are the potential factors
199 contributing to this unsafe act.
200

209 The following factors may force bus user to cross road at undesirable locations by not using the provided
 210 crosswalk facility, while accessing/departing the bus stop (Figure 4d): inadequate width of the crosswalk
 211 (u4f1), locating crosswalk far away from the bus stop (u4f2), invisible crosswalk marking (u4f3), and
 212 vehicle not stopping at a safe distance from the crosswalk (u4f4).

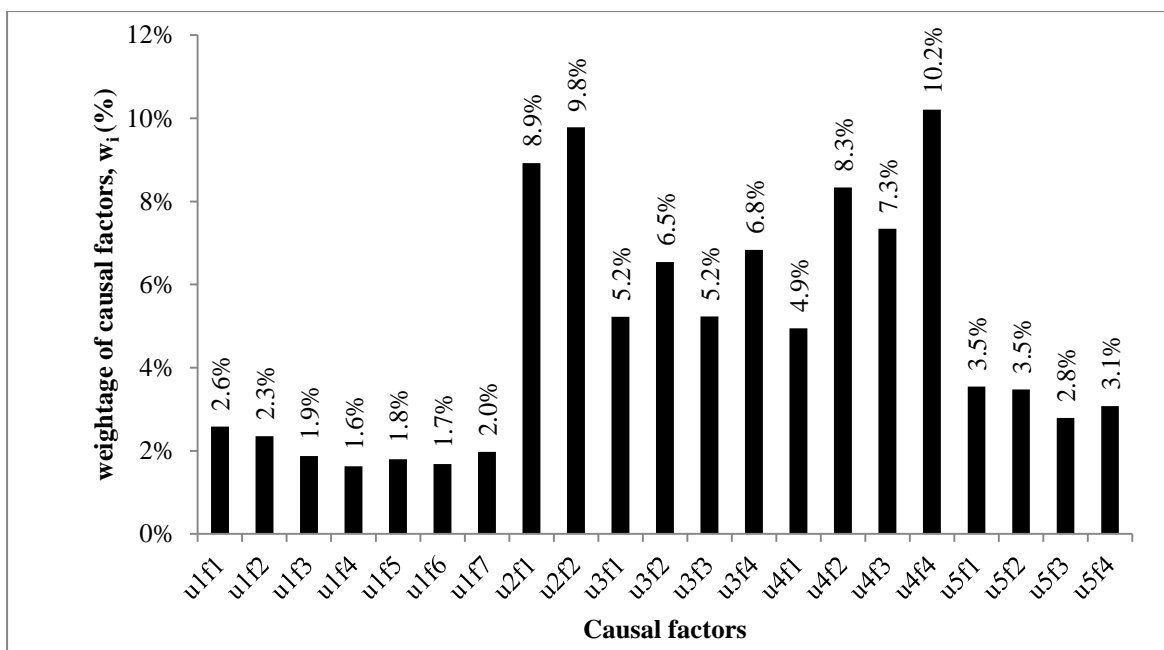
FIGURE 5 Variation of weightage among causal factors

309 As mentioned earlier, weightages (w_i) of the causal factors were obtained by taking the product of
 310 contribution index the (c_{ip}) and degree of danger values (d_p). Initially, weightages given by the individual
 311 experts were calculated, and then the arithmetic means of these individual weightages were reported as
 312 the weightages of causal factors (Figure 5). It was found that, 'vehicle not stopping before crosswalk
 313 (u4f4)' got maximum weightage (10.2%), followed by 'Locating crosswalks at the nearside of the
 314 intersection (u2f2)' (9.8%) and 'locating the cross walk at far side of the loading area (u2f1)' (8.9%). On
 315 the other hand, 'lack of drainage facility (u1f4)' (1.6%), 'encroachment of sidewalk by parked vehicles
 316 (u1f6)' (1.7%) and 'physical obstruction and untidy surroundings (u1f5)' (1.8%) were found to be the
 317 causal factors with least weightages.

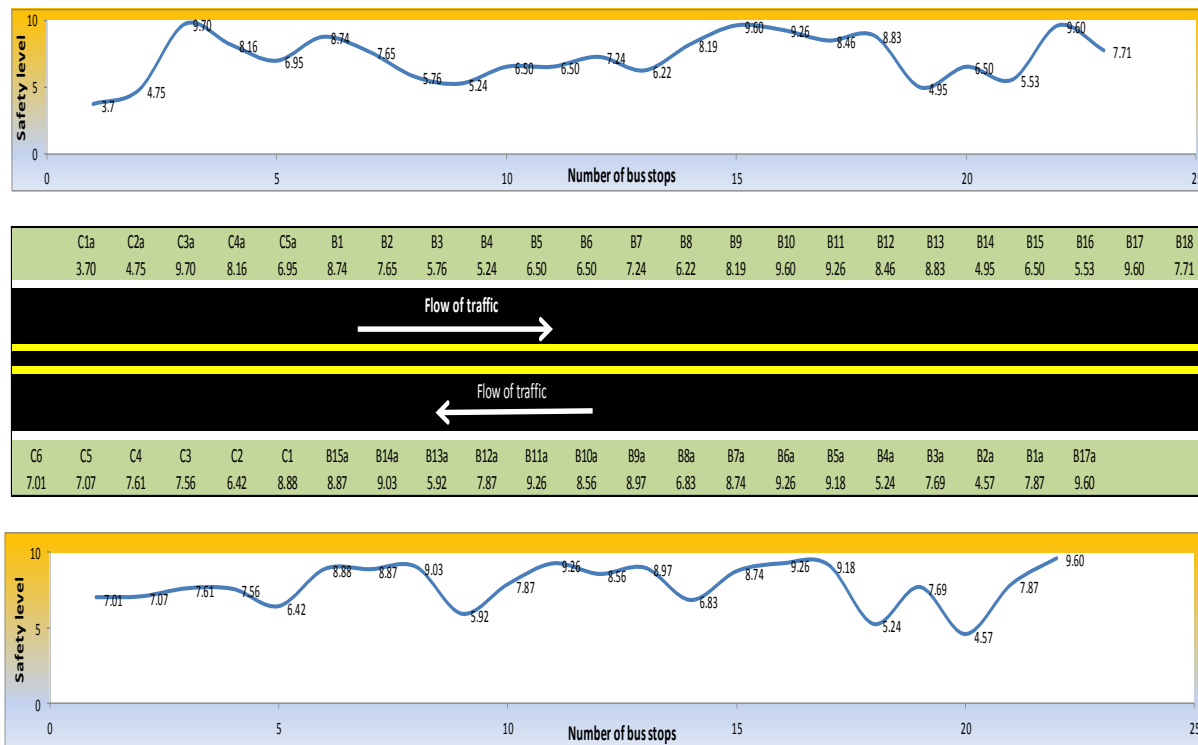
340
 341 **FIGURE 6** Variation of the safety level of bus stops along the study corridor
 342

In this stage, based on the safety level obtained for various bus stops, prioritization of the bus stops was carried out for the fact that lower the safety level higher the priority for improvement. It was found that, Jeevan Deep (Safety Level = 9.7), Hazra junction (Safety Level = 9.6) and Rashbehari (Safety Level =

334 9.6) bus stops respectively were at the bottom three positions in terms of the priority, and on the other
 335 hand, Charu market (Safety Level = 3.7), Park street (Safety Level = 4.3), and Dharmatala (Safety Level
 336 = 5.1) bus stops were at top three positions respectively. In addition, the variation of the safety level of
 337 the bus stops along the corridor is plotted (Figure 6), so that it helps in identifying segments of the
 338 corridor with low safety levels.
 339

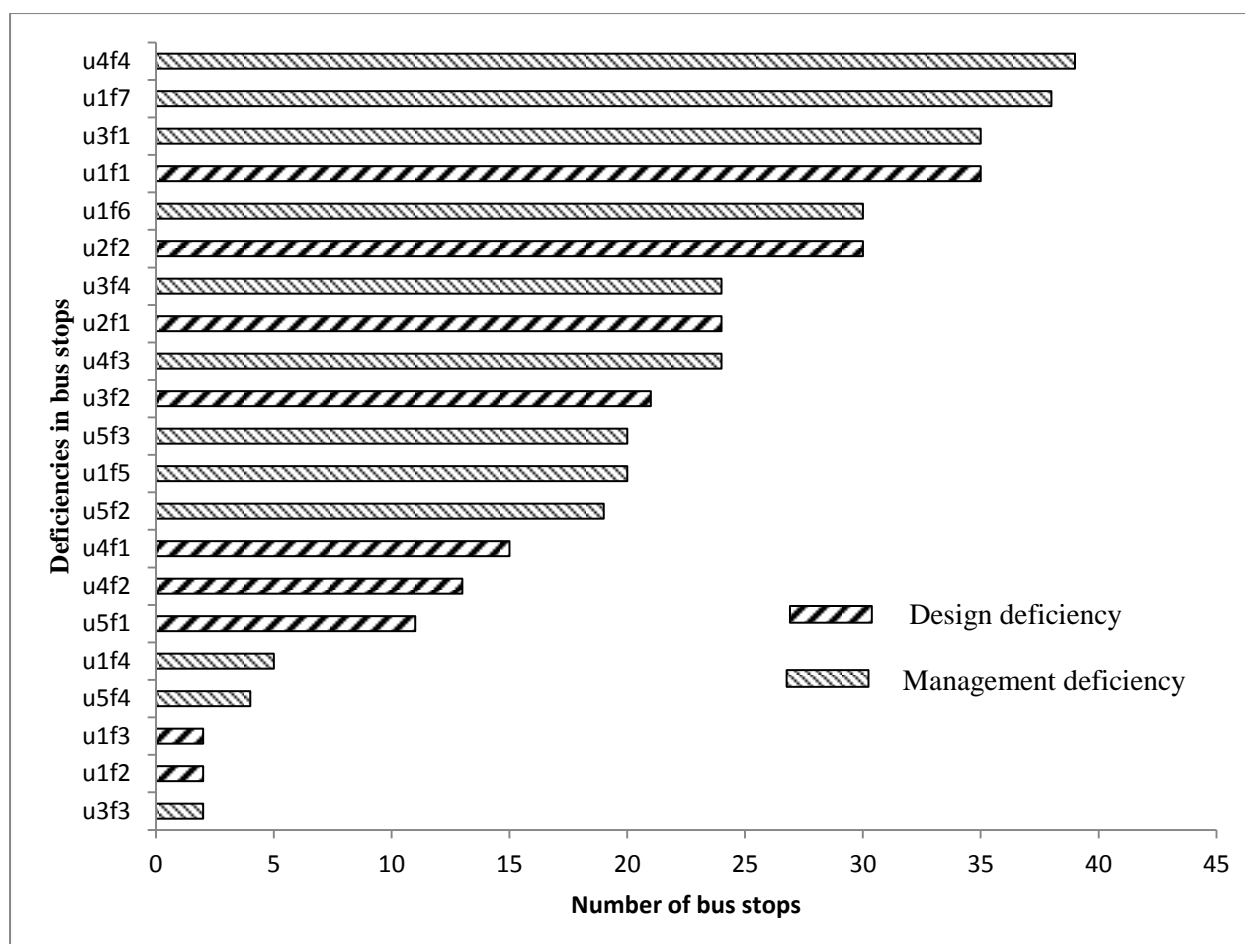
363
364 **FIGURE 7 Frequency of safety deficiencies along the study corridor².**
365

344 After determining the safety levels of 45 bus stops, it was observed that the safety level is varying from
 345 3.7 to 9.7 (10 being best and 0 being worst in terms of safety) and about 40 % of the bus stops have safety
 346 levels less than 7.5. The frequency of occurrence of the safety deficiencies at the bus stops which were
 347 investigated is illustrated in Figure 7. Vehicle not stopping at a safe distance from crosswalk (u4f4),
 348 presence of street vendors along the sidewalk (u1f7), on street parking (u3f1), and absence of waiting area
 349 (u1f1) were the most common deficiencies associated with the bus stops that were investigated. Also, it is
 350 evident from the figure that management deficiencies are dominant over design deficiencies at the bus
 351 stops along the study corridor. Although the study included a safety level assessment (as illustrated for
 352 Charu market bus stop in Table 2) and recommendations to improve the safety level for all 45 bus stops

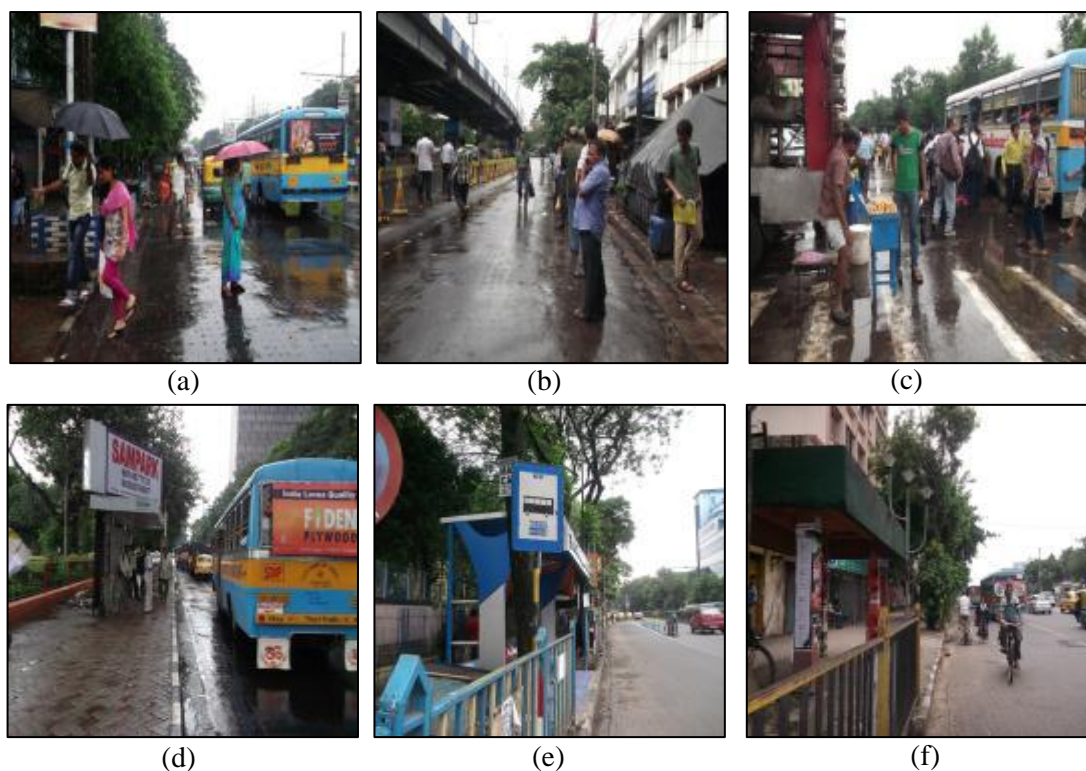
405
406
407
408
409
410
411
412
413
414
415
416
417
418 **FIGURE 8 (a) Charu market bus stop; (b) Park Street bus stop; (c) Dharmatala bus stop;**
 419 **(d) Jeevan Deep bus stop; (e) Hazra junction bus stop; (f) Rashbehari bus stop**

367 Charu market (Figure 8a) (Safety Level = 3.7), Park street (Figure 8b) (Safety Level = 4.3), and
368 Dharmatala (Figure 8c) (Safety Level = 5.1) bus stops were found to be the worst three among 45 bus
369 stops in terms of safety level.

388 Jeevan Deep (Figure 8d) (Safety Level = 9.7), Hazra junction (Figure 8e) (Safety Level = 9.6),
 389 Rashbehari (Figure 8f) (Safety Level = 9.6) bus stops were found to be the best in terms of safety level.
 390 All three bus stops were devoid of any deficiencies related to passenger waiting area and crosswalk
 391 facility. In order to further improve the safety level, it is recommended to discourage the buses at Jeevan
 392 deep from stopping for unreasonably long durations to pick up more passengers and to remove physical
 393 obstructions along the sidewalks in Hazra and Rashbehari.
